PRELIMINARY REPORT ON SOIL EROSION IN BARSAT ON KAIMLA ROAD

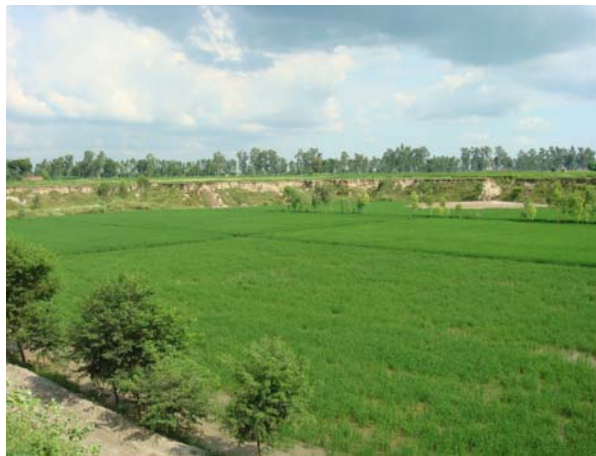
A committee constituted by the director visited the soil erosion sites in Barsat village on Kaimla Road near Ghraunda. A cursory look at the damaged sites revealed that it is not a case of land subsidence but a case of bank erosion adjoining sand mined area. Since the sand mined area has steep almost vertical slope and profile being sandy, the stability of such a steep slope is quite doubtful (Fig. 1). It appears that water pressure in rice fields towards the bank was so high due to rainfall or rainfall following irrigation by the farmer that the upper layer got eroded and then it took no time for the sand in the profile to flow with the water. The area affected was no more than 50 sq. m. in the first case (Fig. 2). It seems that the affected farmer constructed a temporary embankment and it helped to control further damage (Fig. 3). Although currently it seems all right but the same needs strengthening as heavy downpours during August/September cannot be discounted.

Fig. 1. A view of the steep slopes of the mined fields

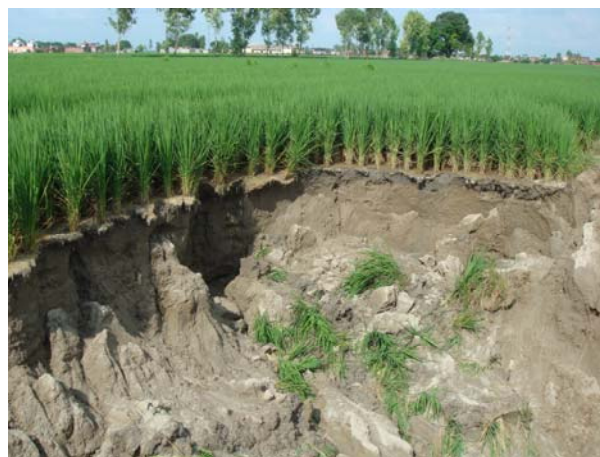
Fig. 2. The damaged area in the non-mined field (About 50 sq. m.)

In conclusion, the team is of the view that it is not a case of land subsidence and is a clear case of bank/soil erosion. As such it has lesser implications and can be tackled with relatively easier interventions than land subsidence. The area damaged is not very large and other farmers need not worry provided they strengthen the dykes of their fields along the mined land.

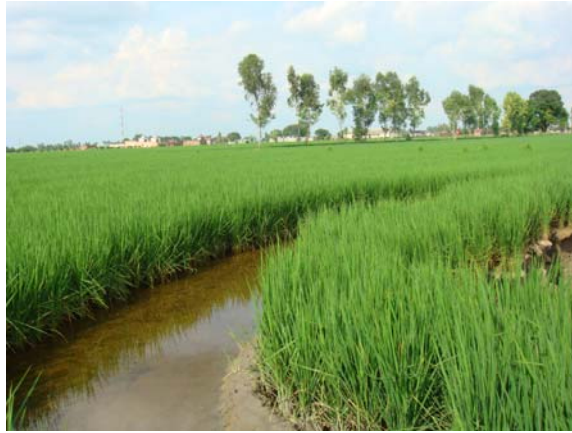
Fig. 3. A temporary embankment to control soil erosion

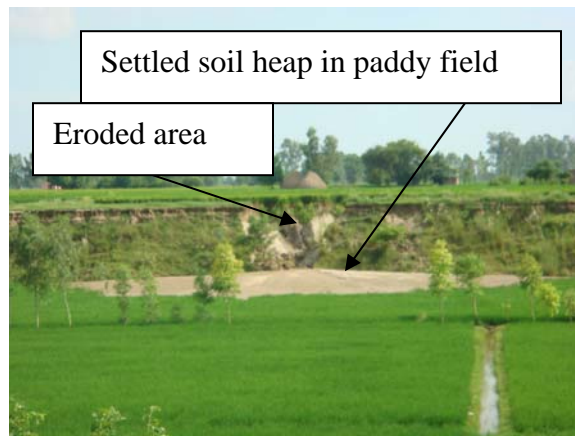
Mr. Ram Niwas, a worker with Chaudhary Ram Singh also approached the team and showed his field on the other side of the embankment having the same problem. Although the team could not reach the other side, the problem was almost similar and could be captured by the camera. Only difference between the fields was that in the first case seen by the committee damage was restricted to the farmer with non-mined land as the material settled on the pathway constructed by the farmer with mined land. On the other hand the eroded soil mass settled in the paddy field of the farmer down below causing damage to his paddy along with the damage to the paddy of the farmer with non-mined fields (Fig. 4).

Fig. 4. The eroded area on the other side embankment of the mined land
